Document Title		Addition of Bushing to Platen Plate

Document #	Rev	Type	Reason	Recommendation	Original Release Date	
ZSB-029	Original	Service Bulletin	Reliability / Safety	Optional / Mandatory	November 10,2021

Addition of Bushing to Platen Plate
Applies to units produced prior to Oct. 2020

Purpose: The purpose of this service bulletin is to advise customers of a product improvement related to the operation and adjustability of the Rotatub Slip Clutch.

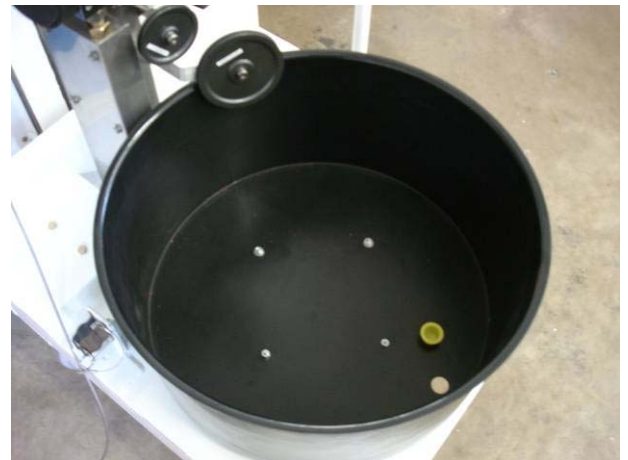
Figure 1 Rotatub Attachment Nuts

1. Remove the Rotatub and Spooler by removing the 1/4-20 lock nuts (4).

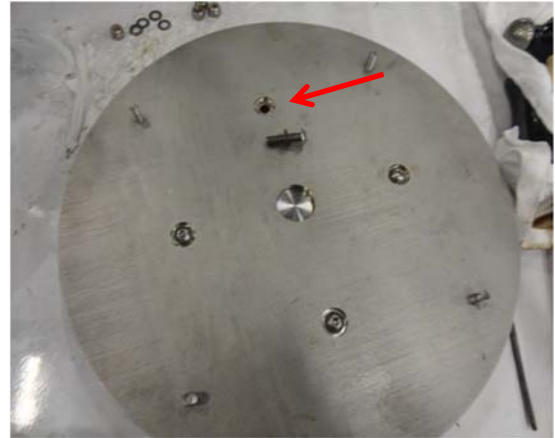
Figure 2 Top Plate Attachment Fasteners

2. Using a 7/16 Box wrench and a 5/32 hex key remove the 1/4-28 bolts (4), being careful to note the position and orientation of the Belleville washers. *See figure 2*

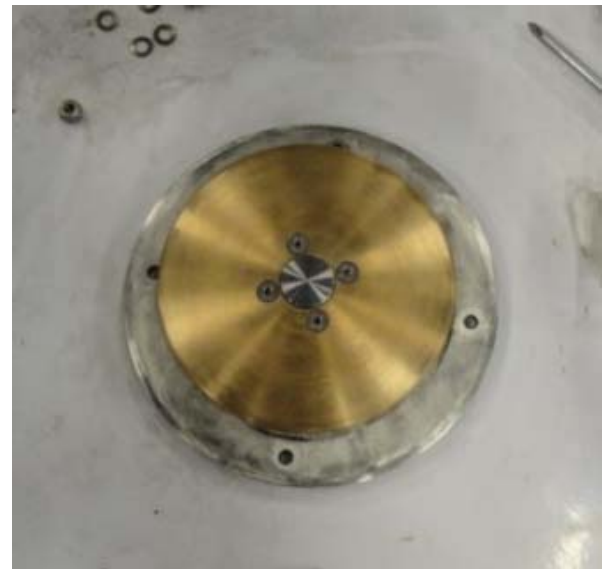
Figure 3 Bronze Plate and Flat Head Screws

3. Remove the top plate and clean all the grease or remove the slip pads from the upper plate.
4. Remove the (4) Flat head screws that attach the bronze disc to the axel shaft, in order to remove the bronze disc. Use of an impact tool may be required. *See figure 3*

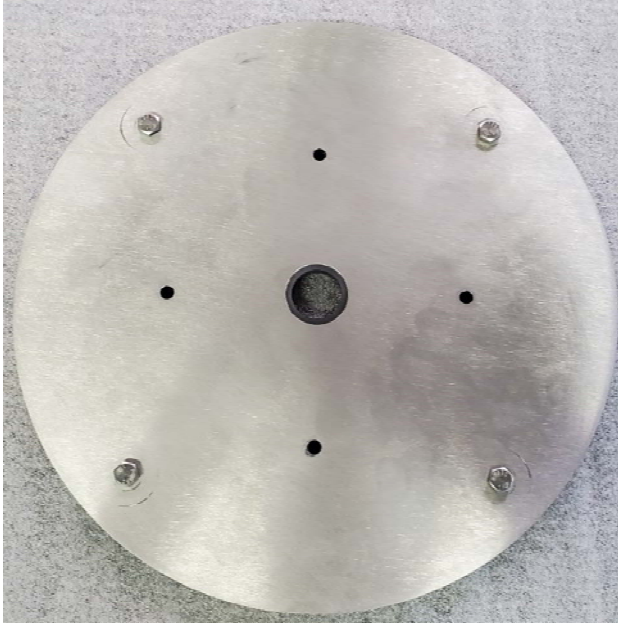
Upon further investigation it was observed that the top edge of the axel shaft was touching the lower edge of the top platen plate. A bushing was added to ensure that an interference between the top edge of the axel and the lower edge of the ID of the plate was eliminated.

The addition of the bushing to the top plate eliminates possible interference between the top edge of the OD of Axel Shaft and the bottom edge of the ID of the top platen plate. Interference may result in difficulty adjusting the Rotatub slip load values. It may result in high Rotatub slip loads resulting in a gap in the cable wrapping on the Spooler. The gaps may then result in not enough space on the spooler for the complete cable length to be wrapped, with the result being that the cable comes out of the Rotatub and gets kinked if the operator does not stop operation fast enough.

Figure 4 Top Plate with Bushing Installed

11. Add the top plate that has the bushing installed, see figure 4, and install the (4) Screws, beveled washers and nuts finger tight. Check that the beveled washer's concave side is facing the top plate from above and the bottom plate from below.

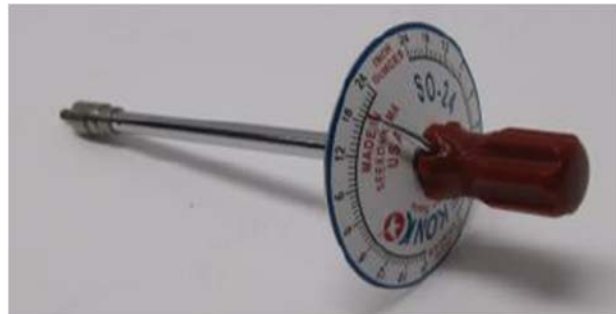
Another observation that resulted from the investigation was that users do not always have access to a torque watch that is required to adjust the screws to the very low torque that is required to allow the Rotatub to slip properly.

Figure 5 Torque Watch 0-24 in-oz

Procedure: The Infinitely Adjustable platen assembly ZGS-10248-1 must be disassembled. The Top Plate ZGS-10180-2 must be replaced or reworked to add the bushing ZGS-10886-1. The slip pads should also be replaced. The adjustment of the revised assembly requires the use of a Torque Watch, see figure 5.

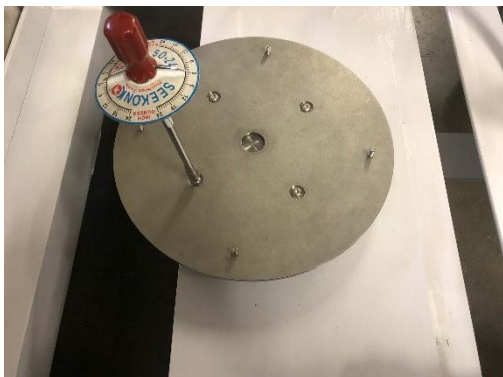
Figure 6 Checking Torque

12. Tighten the screws evenly to obtain 6 in-oz on each screw. This requires holding the nut on the bottom of the screw with the 7/16 hex wrench and tightening the screw with a 5/32 hex key. Then measuring the residual torque to spin the screw using the torque watch, see figure 6. Do not apply torque to tighten the screw with the torque watch.

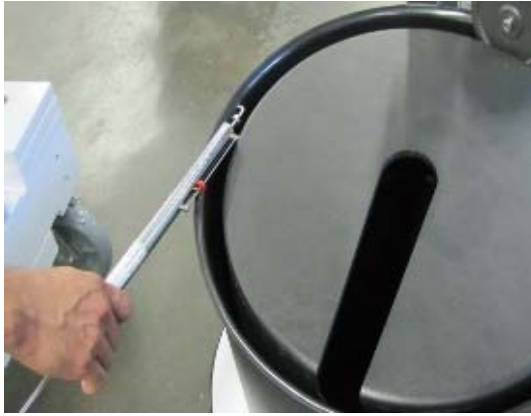
Figure 7 Checking Rotatub Slip Value

13. Place the Rotatub on the (4) studs and use a spring scale to check the breakaway force as shown in figure 7. If it is 2-3 lb. then adjustment is complete. If not remove the Rotatub and adjust the nuts to obtain 6 in-oz when rotated with the torque watch.

14. Attach the Rotatub with the (4) locknuts and washers.
15. Recheck the Rotatub slip value dynamically to verify it is slipping at 2-3 lb. at the hole in the top edge of the Rotatub as shown in figure 7.
