Document Title		Vertical Belt Alignment for Zephyr Hydraulic RHGSE

Document #	Rev	Type	Reason	Recommendation	Original Release Date	
ZSB-013	C 2016/11/22	Service Bulletin	Performance	Mandatory	2015/05/07

Purpose: To alert users of the need to pin the capstan attachment to the shafts of the RHGSE.

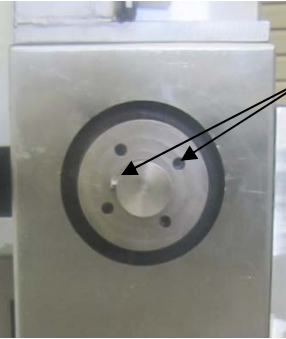
2

Remove the .7 Key and Spacer and set aside for reassembly This will leave the pulley exposed

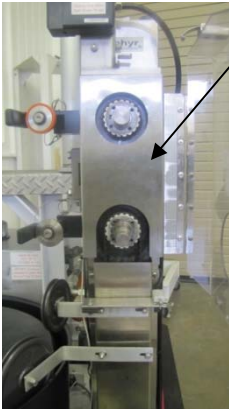
Remove (4) screws and set aside for reassembly from the Chain Guard (2 on each side)

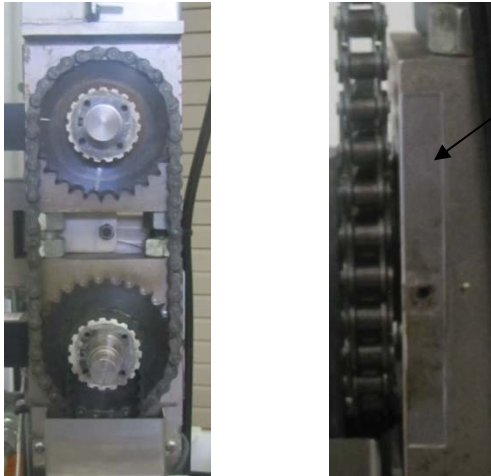
Remove Chain Guard

Verify that plastic shims (4) remain in place on each side of both heads
Attach with Super Glue if needed

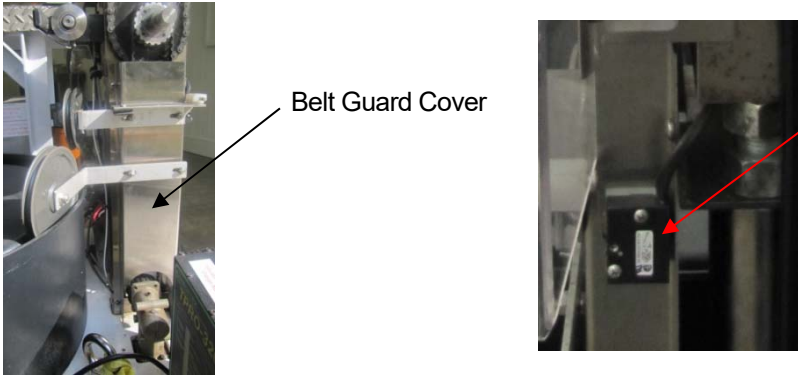
Belt Guard Cover

Remove Limit Switch (If applicable)
Set aside for reassembly

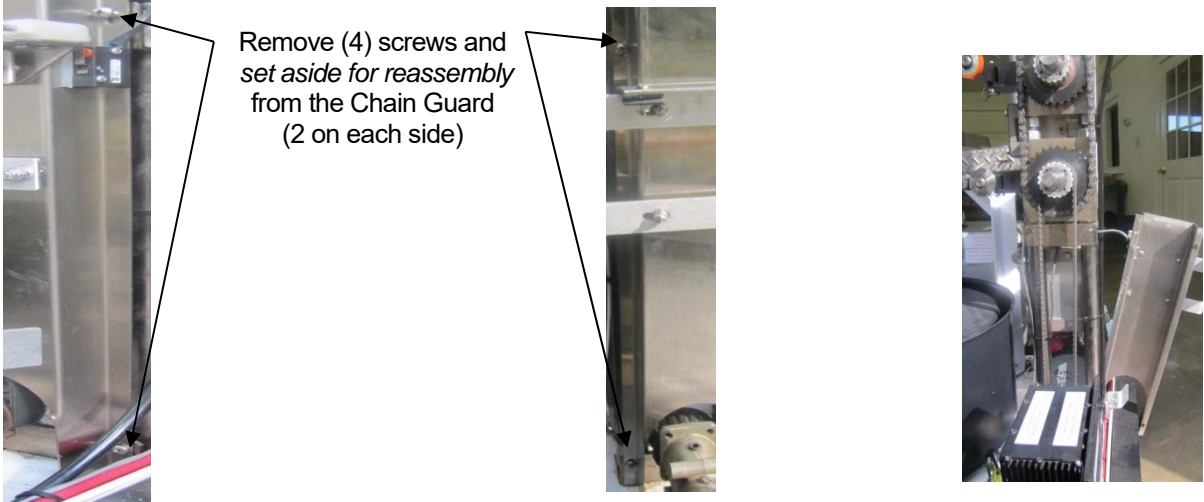
2

Remove (4) screws and set aside for reassembly from the Chain Guard (2 on each side)

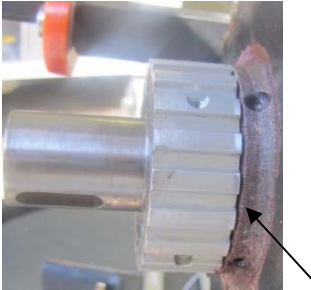
<p>Verify the pulley is flush to the sprocket <i>(If space is visible between pulley and sprocket proceed to next step)</i></p>	<p>2</p>

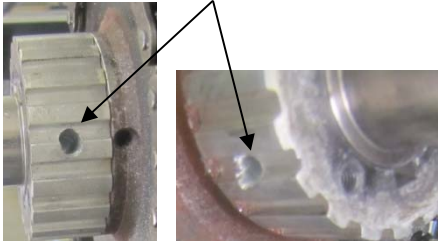
<p>8</p> <p>Insert the ZGS-10803-1 3/16" x 2" Fastening Pin</p>

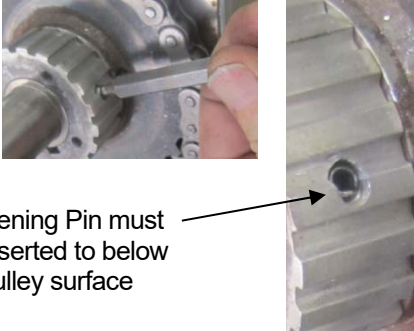
<p>Fastening Pin must be inserted to below pulley surface</p>

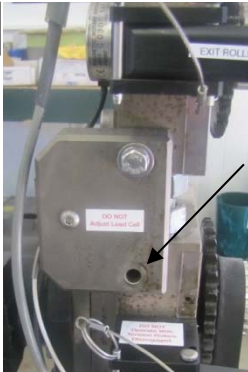
2

Remove the lower bolt from the Load Brake Support

Belt will loosen and can be removed

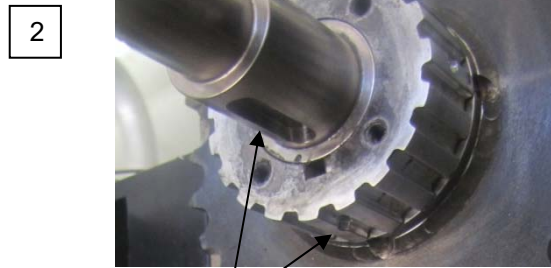
Tap pulley back into place so it is flush with the sprocket

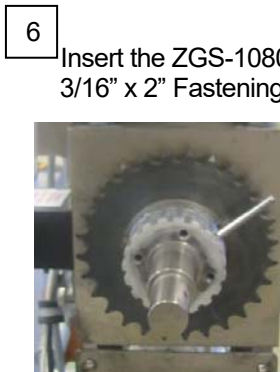
Check both hole locations and remove any burrs that remain

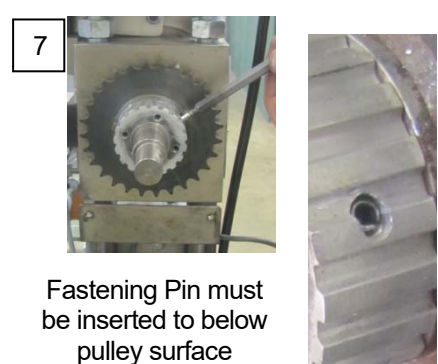
Insert the ZGS-10803-1 3/16" x 2" Fastening Pin

Fastening Pin must be inserted to below pulley surface

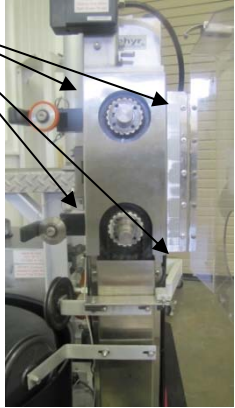
<p>Attach using the (4) screws that were removed from the Chain Guard (2 on each side)</p> <p>Verify that plastic shims (4) remain in place on each side of both heads <i>Attach with Super Glue if needed</i></p> <p>Chain Guard</p>

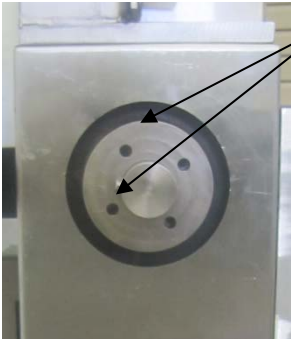
<p>Attach the spacer and .7 key that were removed from the Top Head</p>	<p>2</p>

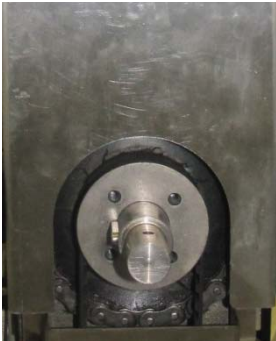
<p>Attach the spacer and .8 key that were removed from the Bottom Head</p>
---	---
